DOT/FAA/AM-06/10
Office of Aerospace Medicine
Washington, DC 20591

Vaporized Hydrogen Peroxide (VHP[®]) Decontamination of a Section of a Boeing 747 Cabin

Final Report

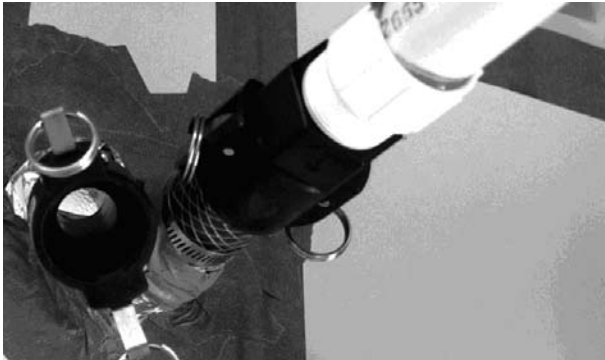
Photograph 1.

Figure 3. Photograph 1 showing the bulkhead penetration of the VHP Inlet pipe and VHP Return (open connector) into the test section of the AERF. Photograph 2 showing the STERIS model 1000 VHP.

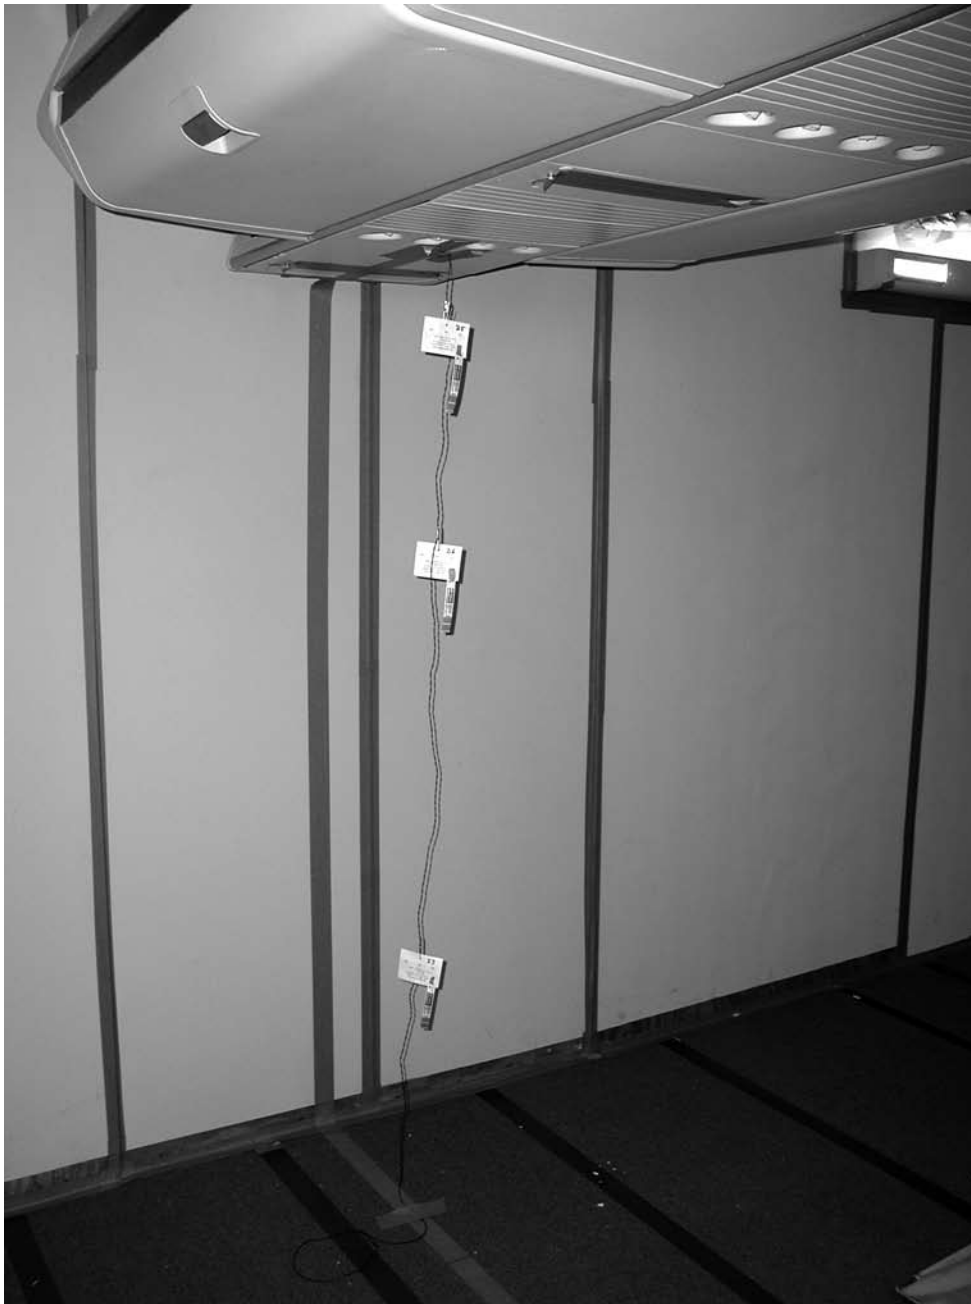
Figure 6. Photograph of BIs and CIs (positions no. 25 – 27, as shown in Figure 7 and identified in Table I) attached to wire in preparation for testing.

Biological Indicators (BIs): BIs were used to provide functional assessments of the VHP level present in the cabin. The biological indicators were tri-pack stainless steel coupons inoculated with approximately 10⁴, 10⁵, and 10⁶ colony forming units (CFU) with *Geobacillus stearothermophilus* spores packaged in sub-divided Tyvek®* envelopes (Apex Laboratories, Inc.). The CI and BI packets were distributed throughout the cabin segment using wires with paper clips located at positions to give the desired height for each BI/CI set. The CI/BI locations were numbered sequentially (1 – 53) and located in the cabin segment as shown in Figure 7. In addition to the BIs exposed during the testing, two indicators that were not exposed to VHP treatment were cultured as a positive growth control. Following each test the BIs were left sealed in their Tyvek envelopes, packaged separately from the controls, and transported to STERIS laboratories for analysis.
